## **PHASE I ENVIRONMENTAL SITE ASSESSMENT REPORT**

**TRI-LAKES CONTAINER WAREHOUSE  
 505 STRAUSS PROVIMI ROAD  
 NORTH MANCHESTER, INDIANA**

**SME Project No.: 064801.00.001.015  
 October 21, 2013**

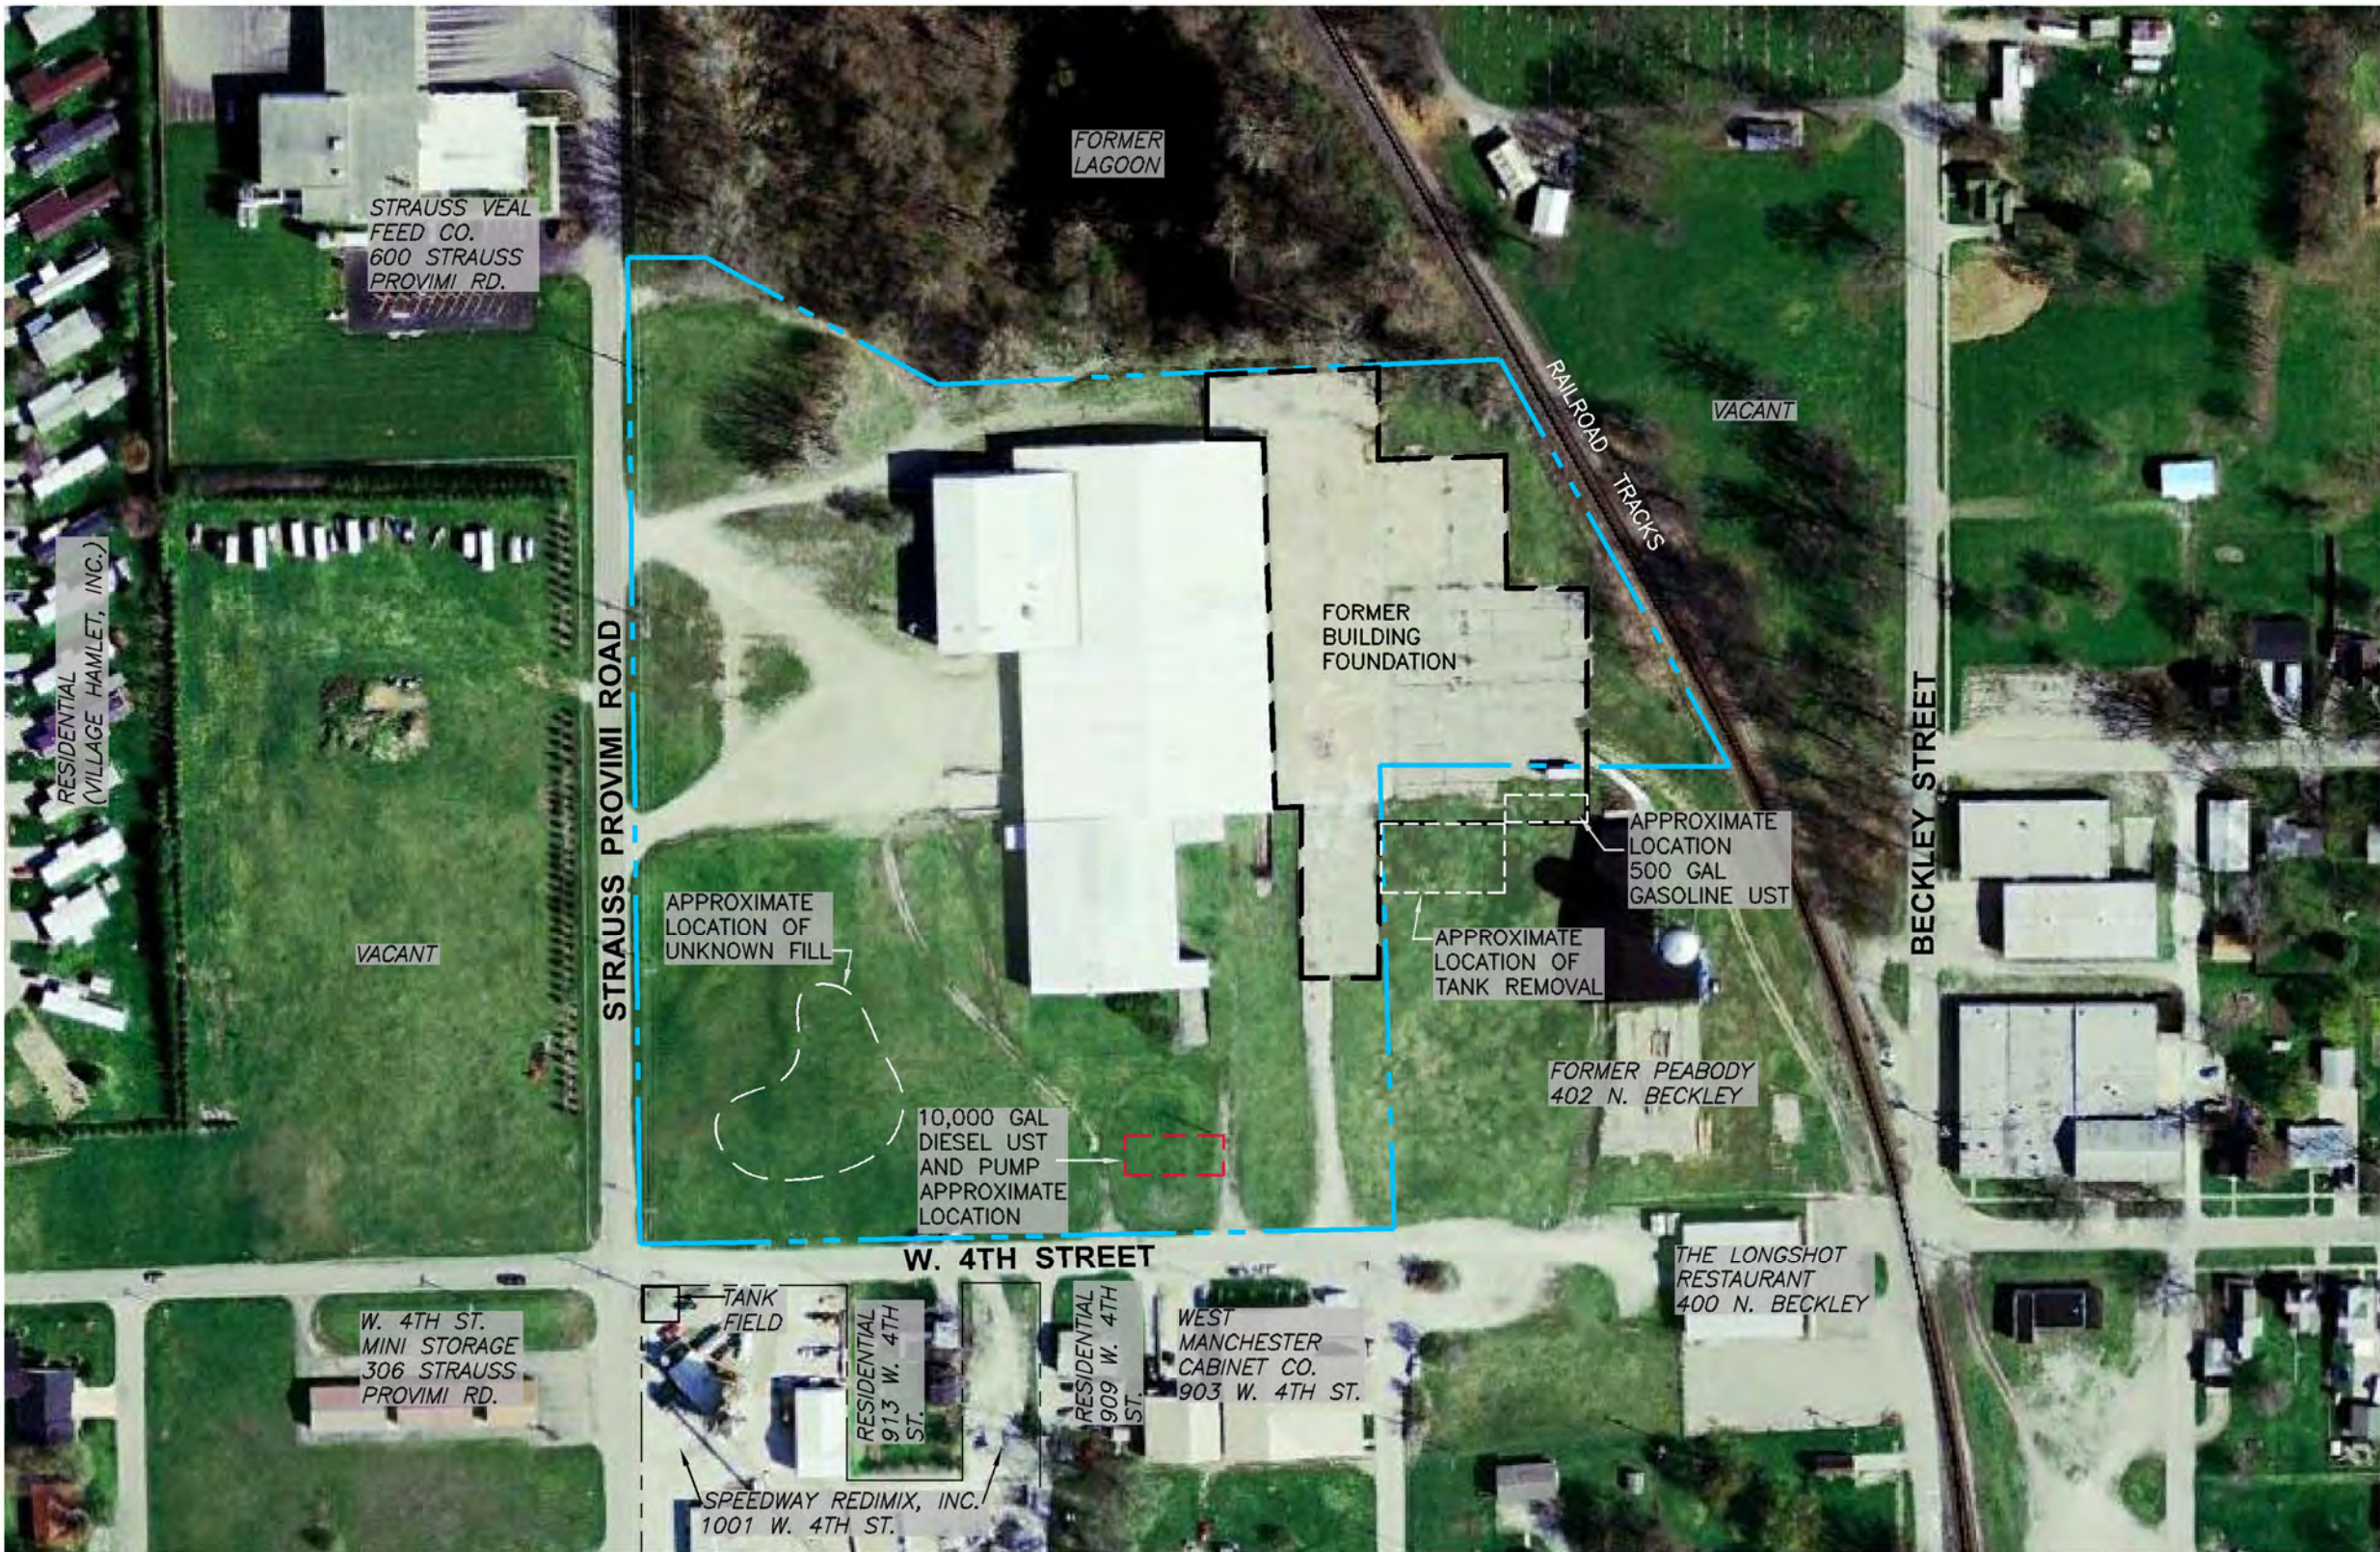
Figure No. 2

NOTE:  
DRAWING INFORMATION TAKEN FROM GOOGLE EARTH PRO WITH  
IMAGE DATE 3-1-2005, SITE RECONNAISSANCE, 10-10-1986  
NOTIFICATION FOR UNDERGROUND STORAGE TANKS, DATED  
10-28-93 BIO-REM INC.®, CLOSURE REPORT.

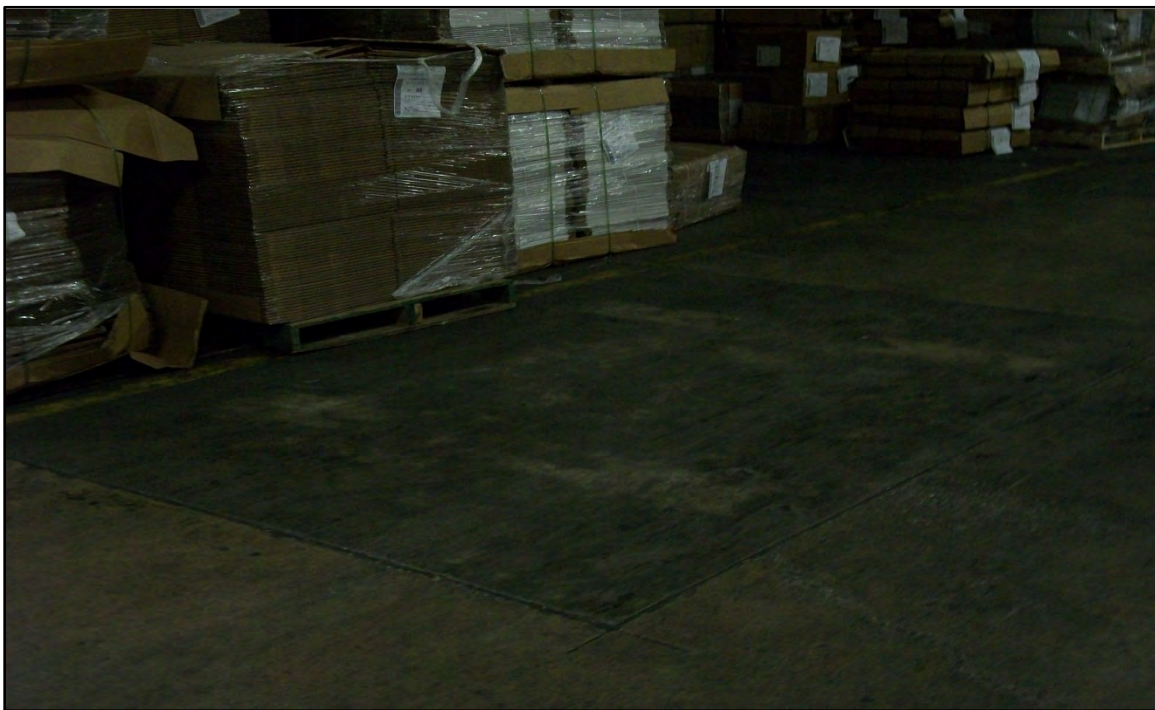
PHOTO NO. 7: View of a typical concrete patch, presumed to be the location of former industrial equipment. Located in the western portion of the building.

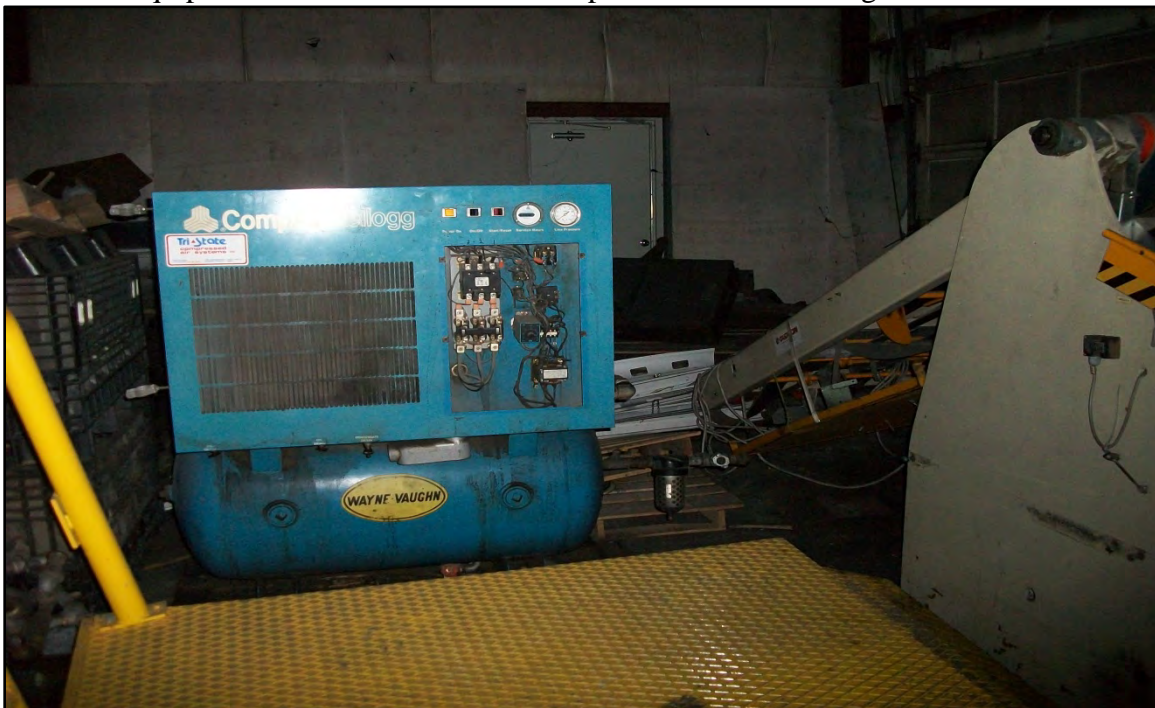
Ms. Welsh observed machinery stored in the southern portion of the building. One machine had leaked a minimal amount of oil and the staining was noted as *de minimis*. Several quart-size containers of motor oil and other small various chemical bottles were stored on the western side of the building. No leaking or staining was noted, therefore the chemical storage does not represent a suspect REC in connection with the Property.

PHOTO NO. 8: View of typical idle machinery storage, located in the southern portion of the building.

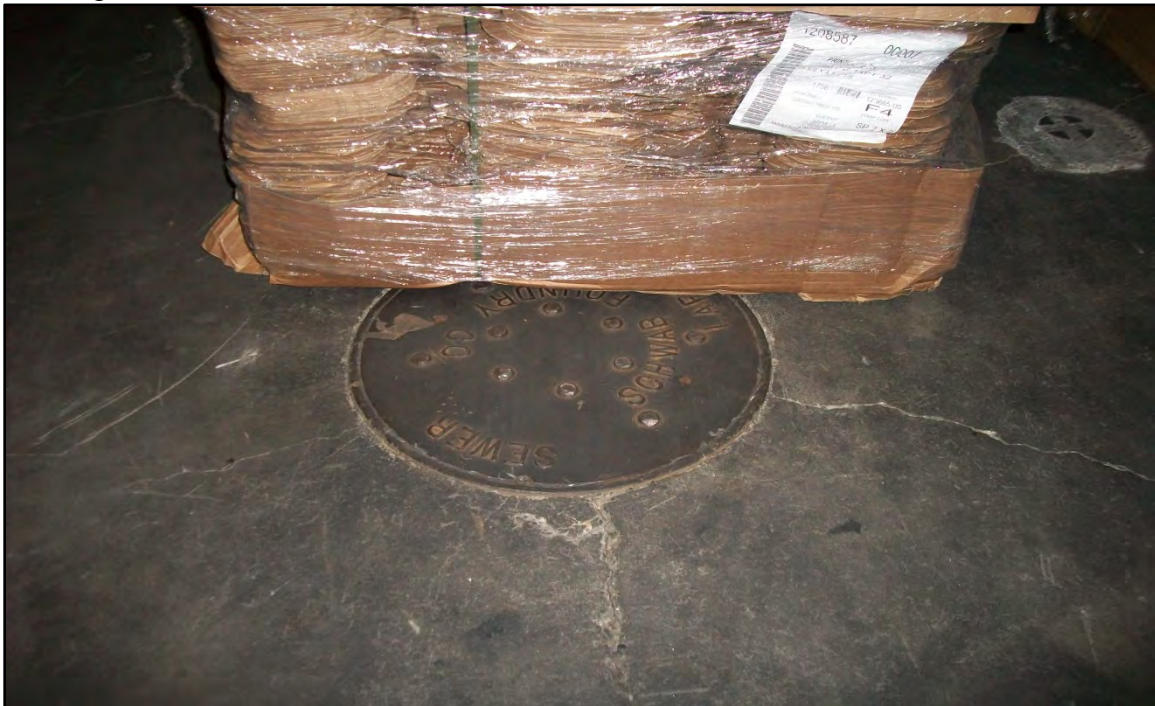
Ms. Welsh observed floor drains in the bathroom areas near the center of the building. Ms. Welsh also noted a sewer manhole on the eastern side of the building. No staining was noted around the floor drains.

PHOTO NO. 10: View of the sewer manhole located in the eastern portion of the building.

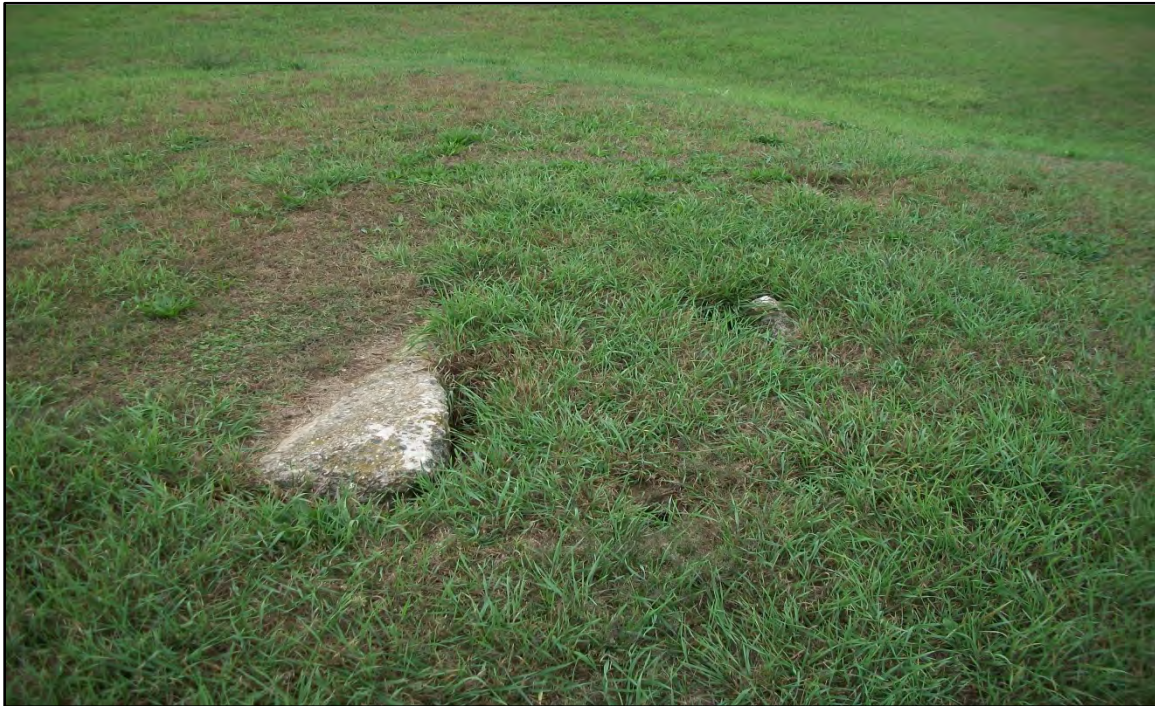
Ms. Welsh observed uneven topography and evidence of fill in the Property's southwestern portion. The potential fill from an unknown source represents a suspect REC in connection with the Property. Two, four-inch vertical PVC pipes were located north of the building. The PVC pipes appeared to have well caps wedged into the top, indicating that they may have been monitoring wells. They did not appear to be related to any historical processes performed at the building; therefore they do not represent a suspect REC in connection with the Property.

PHOTO NO 11: View of fill from an unknown source, located in the southwest portion of the Property.

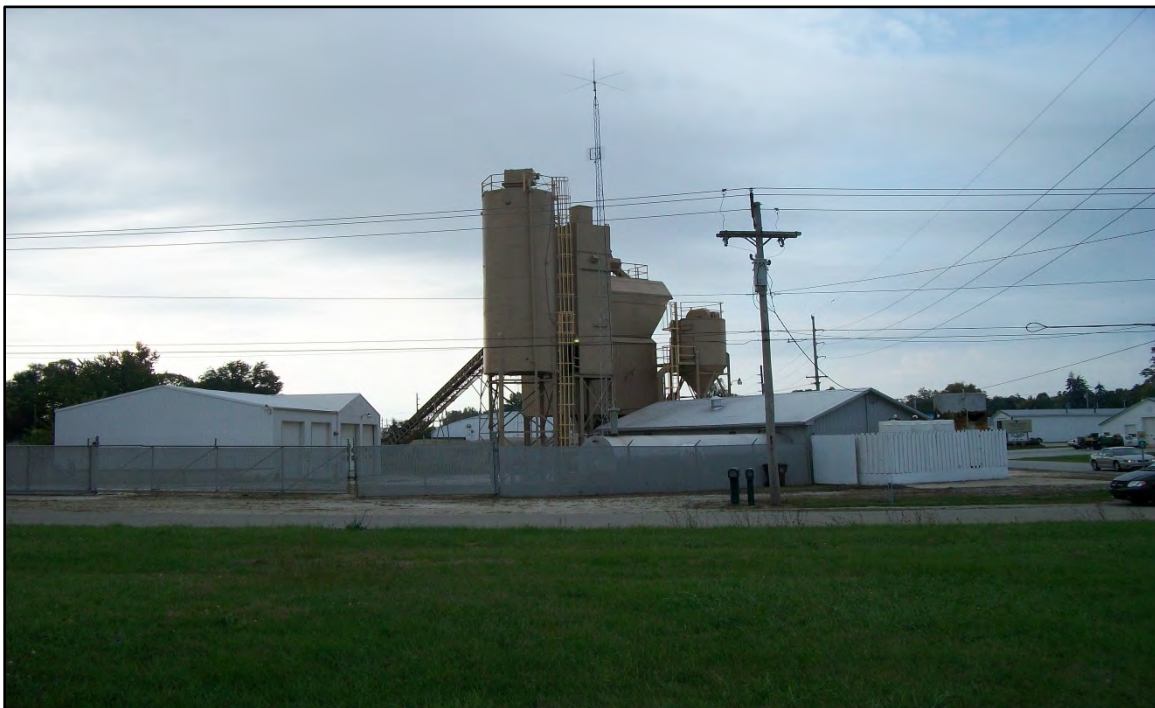
PHOTO NO. 14: View of the south adjoining Speedway Redimix, Inc. Shows large AST and AST tank field.
